STAGE A: ACID SULFATE SOILS INVESTIGATION - MARDIE SALT PROJECT

PREPARED FOR BC IRON LIMITED

October 2017

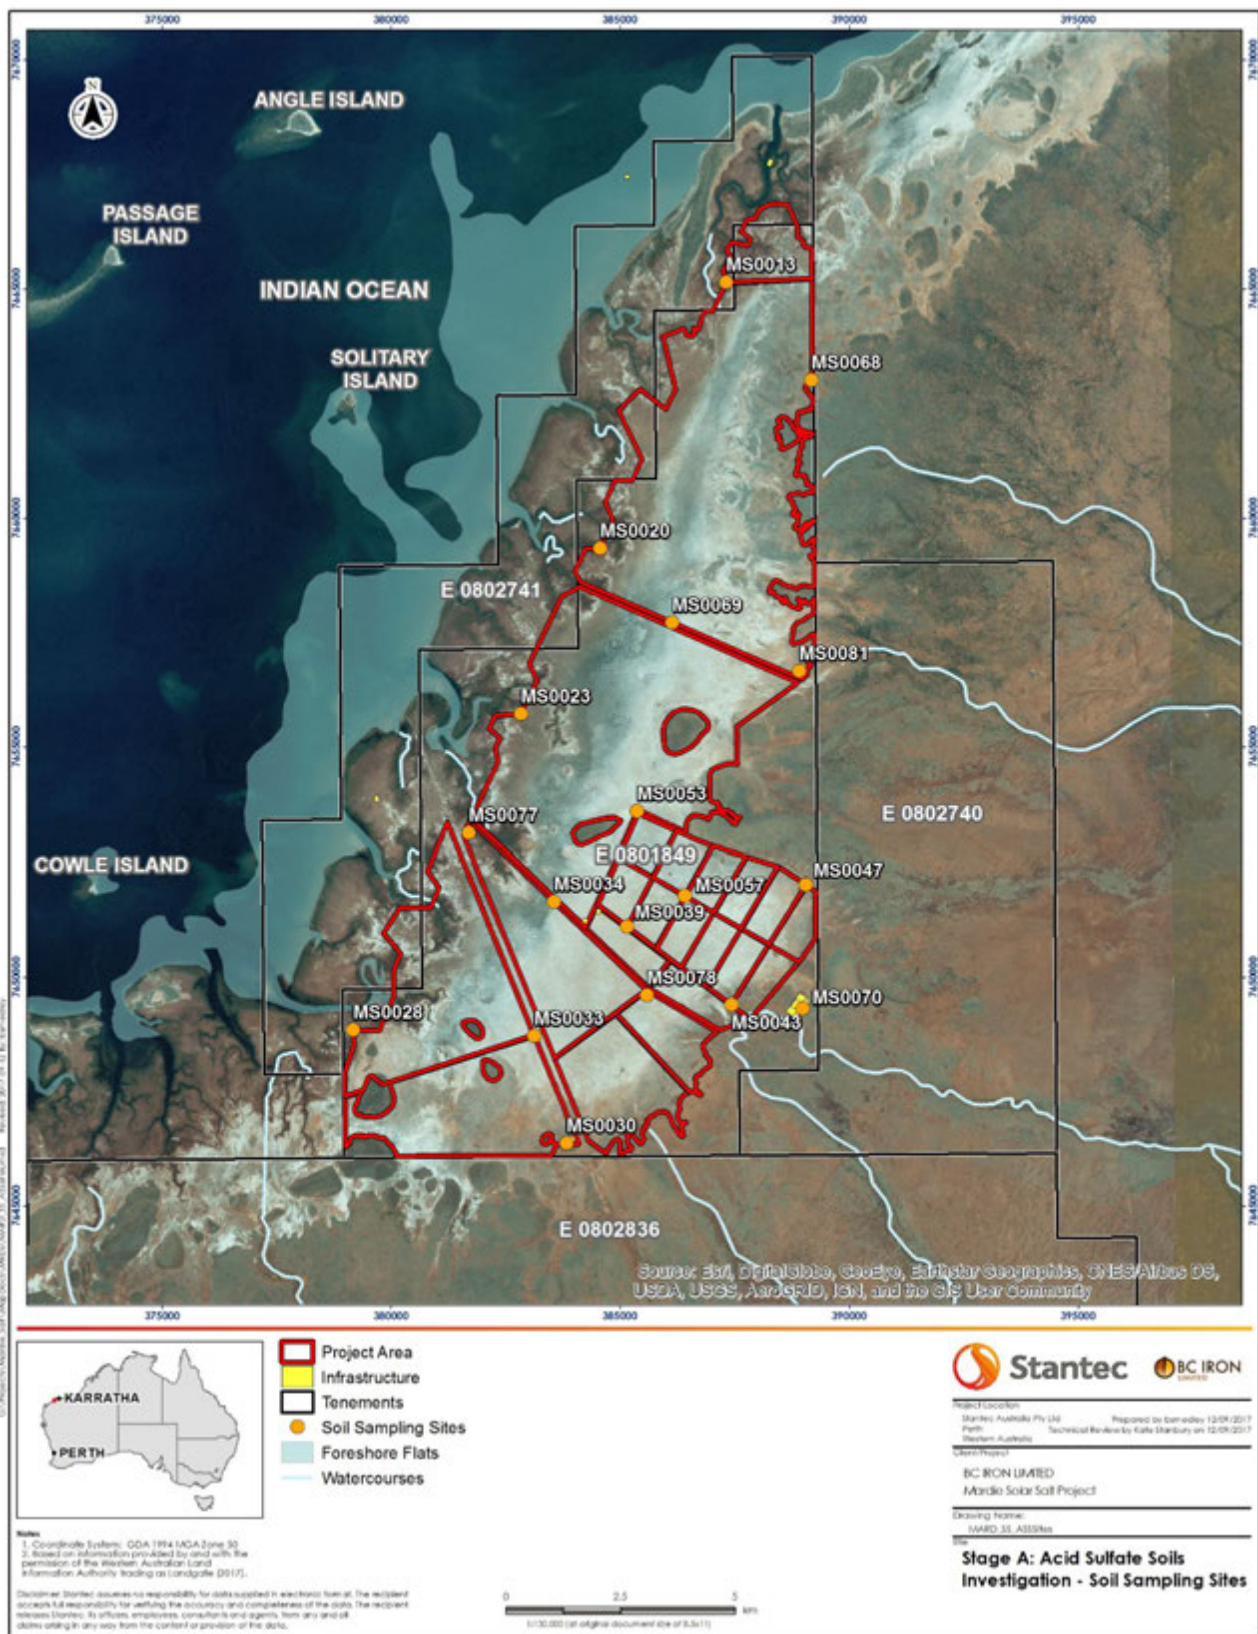
A preliminary site inspection was completed by Stantec personnel in mid-August 2017. The sampling survey comprised logging, sampling and analysis of 18 'near surface' soil profiles within the potential disturbance areas (**Table 3-1**). The soil locations targeted for sampling were derived from previous geotechnical sampling points located within the Project area (**Figure 3-1**).

Figure 3-1: Soil sample locations within the Project area

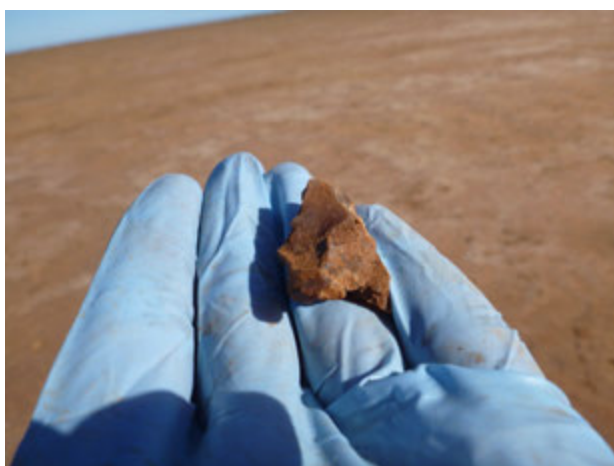
The soils sampled within the Project area were generally found to be red-brown silty sands to silty clays with no visible signs of mottling. Few shell fragments, minor salt precipitation, and gravel (variable in abundance) were common across the sample site surfaces. The majority of soil profiles showed little variation in field properties with depth (up to 1.0 mbgl). Angular gypsum crystals up to 3 cm in size were observed in the subsoil (0.5 to 0.7 mbgl) of sample site MS0034 (**Figure 4-1**). Several soil profiles located within or in close proximity to the proposed crystalliser ponds were found to have a clay hardpan or limestone sub-layer between 0.5 to 1.0 mbgl.

Figure 4-1: Gypsum crystals present within the sub-soil at sample location MS0034

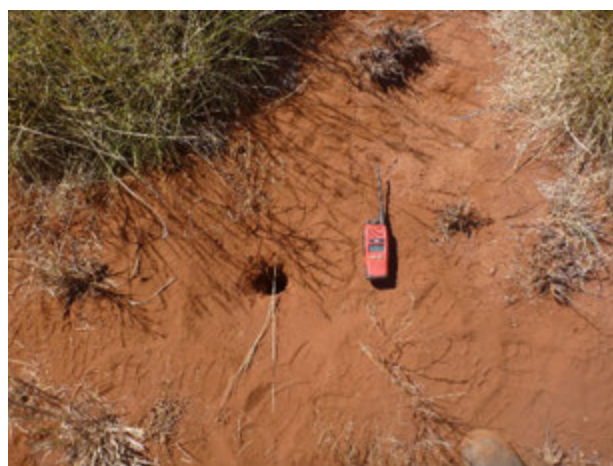
Figure 4-2: Soil texture and vegetation present at sample location MS0070

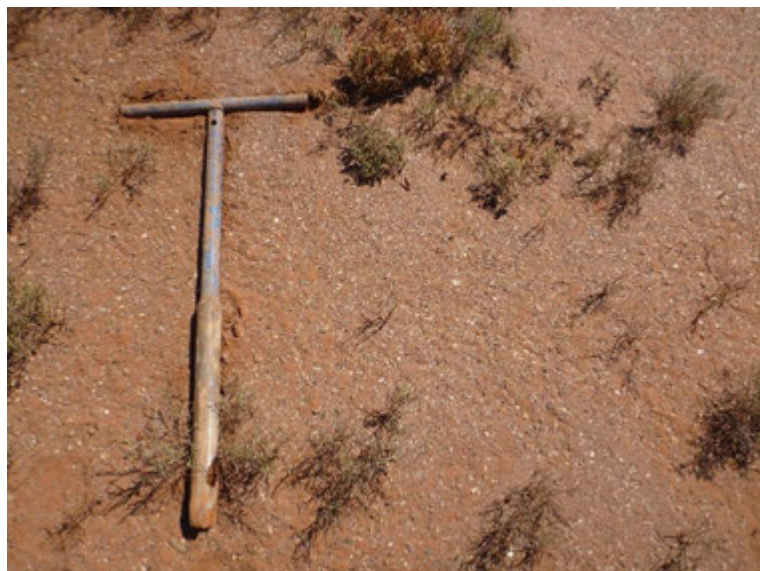
Plate B-1: Soil surface at Site MS0013

Client: BC Iron Limited
Date: 15 August 2017
Location: Mardie Salt Project

Datum: UTM, GDA 94, Zone 50 K
Coordinates: **Easting:** 387315 mE **Northing:** 7665152 mN
Land System: Littoral land system

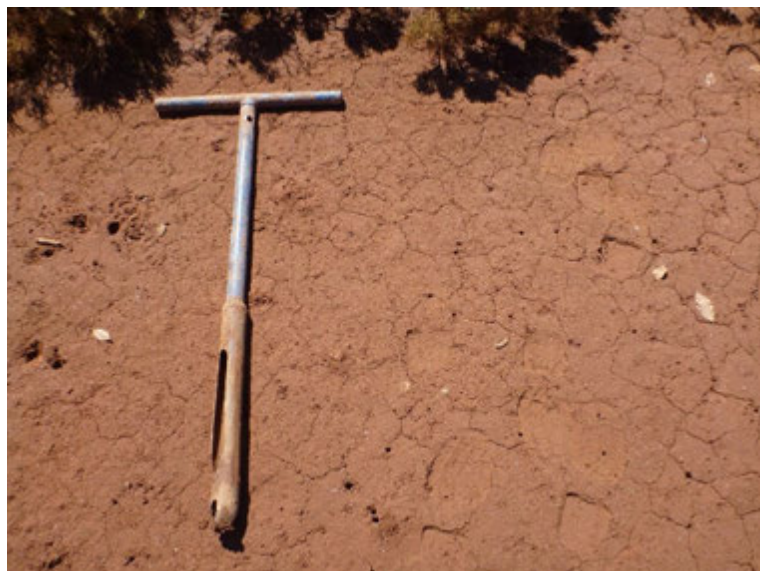
Plate B-2: Soil surface at Site MS0020

Depth	Material	Sample ID	Description
0 mbgl:	Topsoil	MS0020	Red-brown silty clay with very few shell fragments. Damp. Minor salt precipitation and surface crusting / cracking on surface. No signs of mottling throughout profile. No organic matter present. Water table at approximately 0.8 mbgl.
0.25 mbgl:	Topsoil		
0.5 mbgl:	Subsoil		
0.75 mbgl:	Subsoil		
1.0 mbgl:	Subsoil

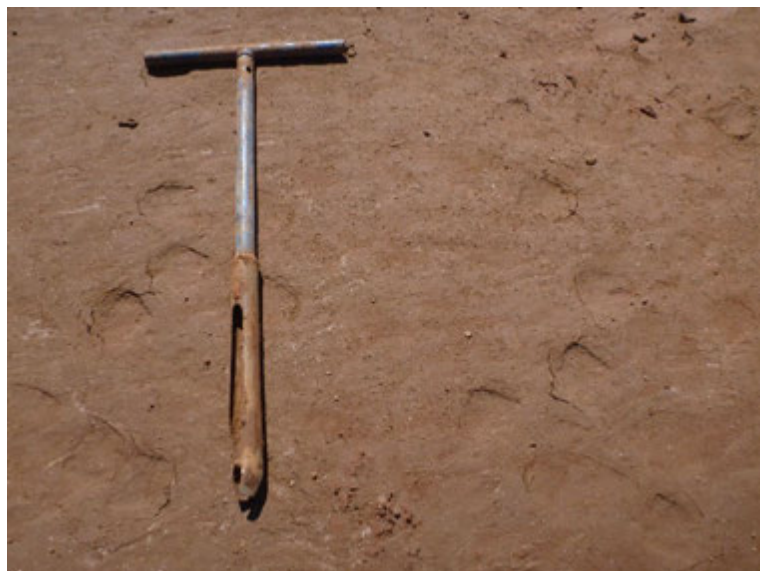
Plate B-3: Soil surface at Site MS0023

Client: BC Iron Limited
Date: 15 August 2017
Location: Mardie Salt Project

Datum: UTM, GDA 94, Zone 50 K
Coordinates: **Easting:** 384565 mE **Northing:** 7655727 mN
Land System: Littoral land system

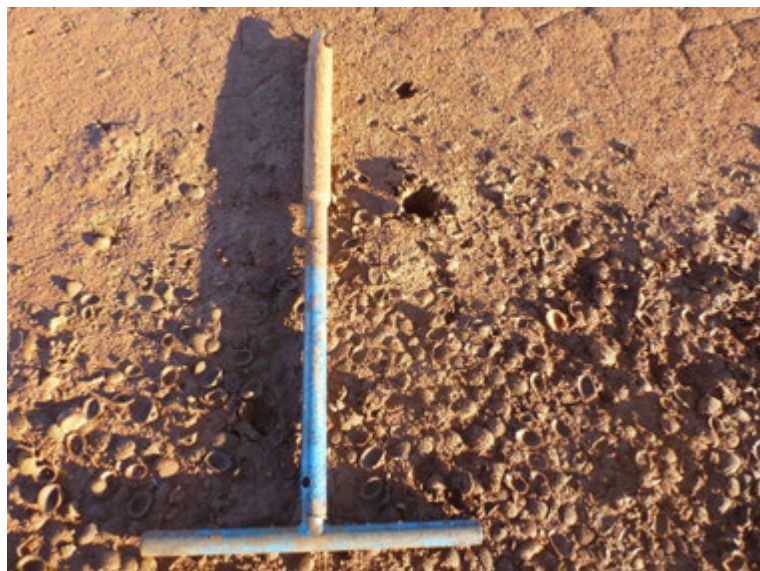
Plate B-4: Soil surface at Site MS0028

Depth	Material	Sample ID	Description
0 mbgl:	Topsoil	MS0028	Red-brown silty clay with abundant shells. No signs of mottling throughout profile. No organic matter present. Water table at approximately 0.5 mbgl. Unable to sample soil at 1.0 m due to high moisture content and mud-like consistency of the soil. As a result, the sample was not able to be collected by the auger.
0.25 mbgl:	Topsoil		
0.5 mbgl:	Subsoil		
0.75 mbgl:	Subsoil		
1.0 mbgl:	Subsoil (not sampled)

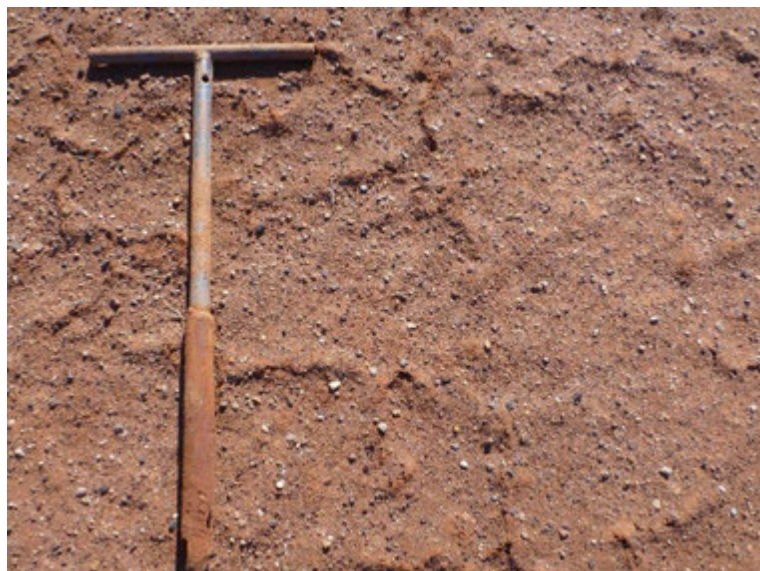
Plate B-5: Soil surface at Site MS0030

Client: BC Iron Limited
Date: 16 August 2017
Location: Mardie Salt Project

Datum: UTM, GDA 94, Zone 50 K
Coordinates: **Easting:** 383839 mE **Northing:** 7646371 mN
Land System: Littoral land system

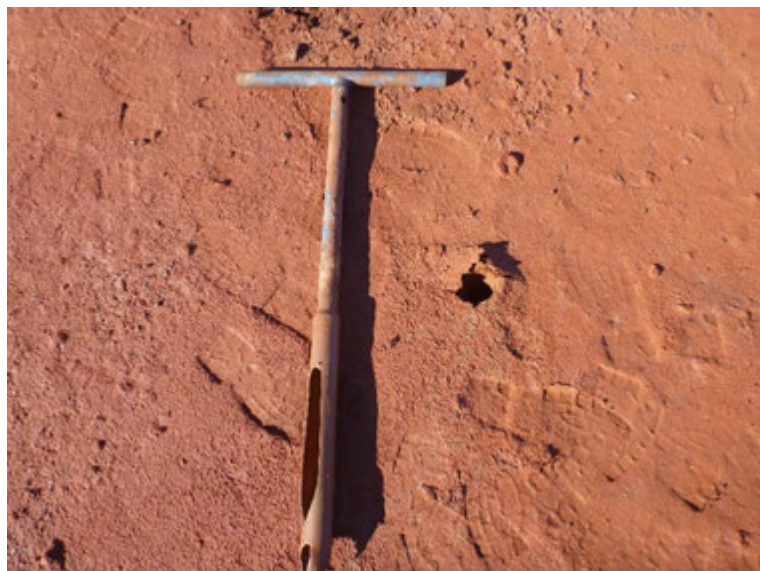
Plate B-6: Soil surface at Site MS0033

Depth	Material	Sample ID	Description
0 mbgl:	Topsoil	MS0033	Red-brown silty clay with very few stone-sized coarse fragments. Damp. No signs of mottling throughout profile. No organic matter present. Water table at approximately 0.5 mbgl. Unable to sample soil deeper than 0.5 m due to high moisture content and mud-like consistency of the soil. As a result, the sample was not able to be collected by the auger.
0.25 mbgl:	Topsoil		
0.5 mbgl:	Subsoil		
0.75 mbgl:	Subsoil (not sampled)		
1.0 mbgl:	Subsoil (not sampled)

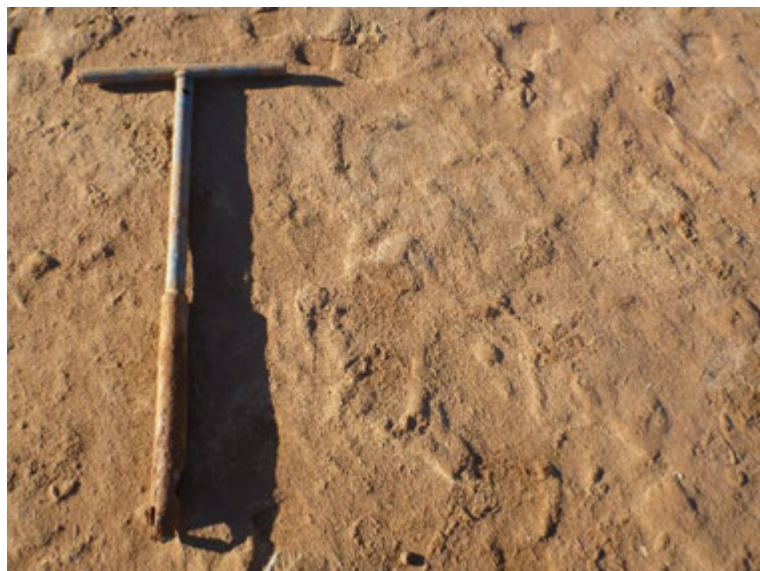
Plate B-7: Soil surface at Site MS0034

Client: BC Iron Limited
Date: 16 August 2017
Location: Mardie Salt Project

Datum: UTM, GDA 94, Zone 50 K
Coordinates: **Easting:** 383560 mE **Northing:** 7651645 mN
Land System: Littoral land system

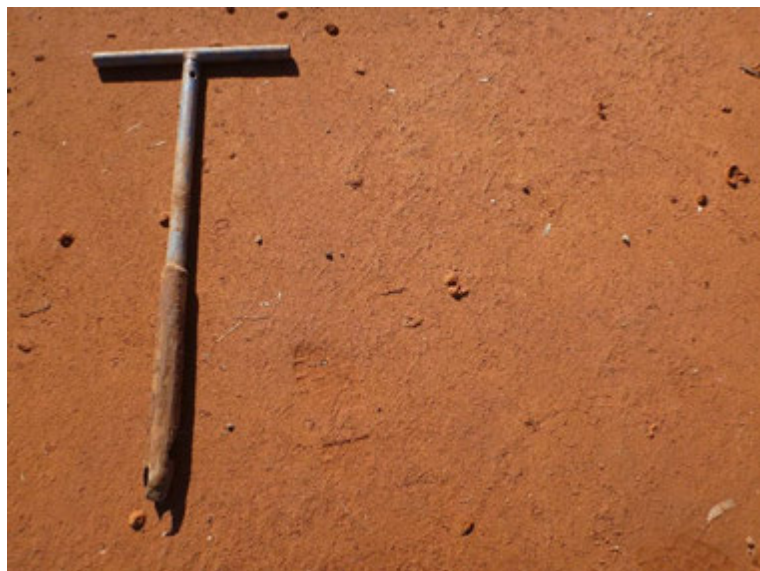
Plate B-8: Soil surface at Site MS0039

Client: BC Iron Limited
Date: 16 August 2017
Location: Mardie Salt Project

Datum: UTM, GDA 94, Zone 50 K
Coordinates: **Easting:** 385159 mE **Northing:** 7651101 mN
Land System: Littoral land system

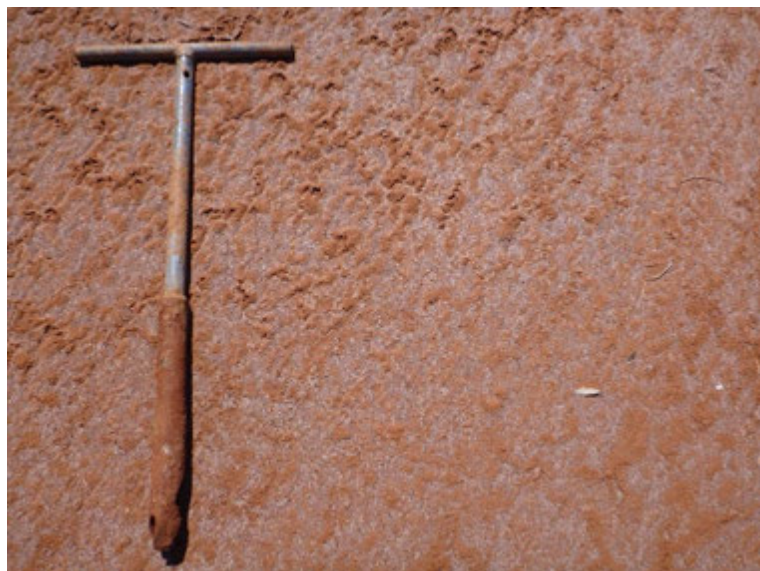
Plate B-9: Soil surface at Site MS0043

Client: BC Iron Limited
Date: 16 August 2017
Location: Mardie Salt Project

Datum: UTM, GDA 94, Zone 50 K
Coordinates: **Easting:** 387433 mE **Northing:** 7649396 mN
Land System: Littoral land system

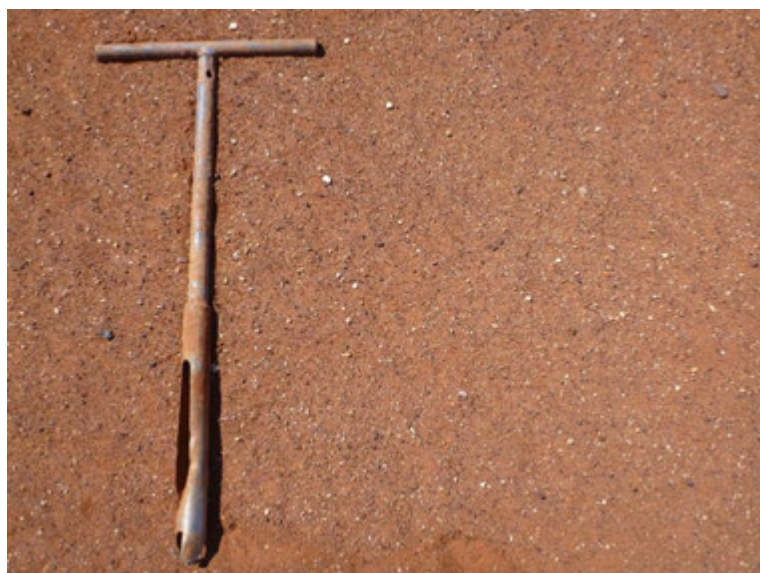
Plate B-10: Soil surface at Site MS0047

Client: BC Iron Limited
Date: 16 August 2017
Location: Mardie Salt Project

Datum: UTM, GDA 94, Zone 50 K
Coordinates: **Easting:** 389062 mE **Northing:** 7652012 mN
Land System: Onslow land system

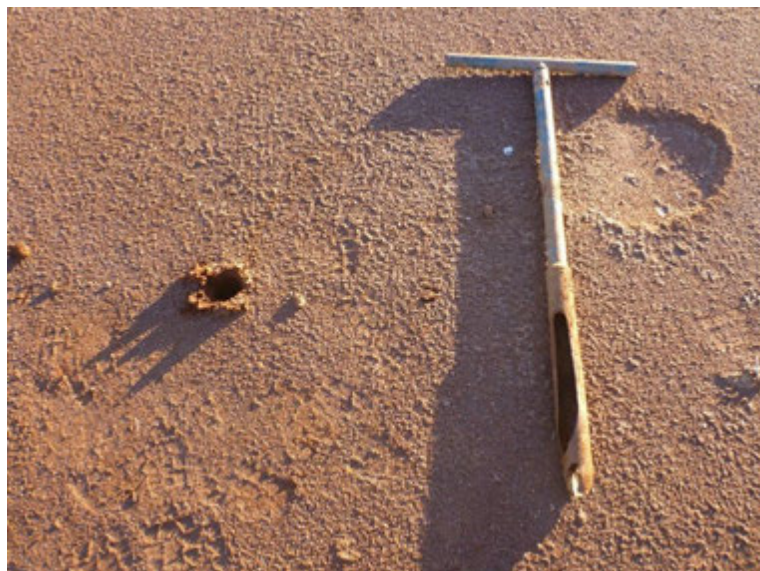
Plate B-11: Soil surface at Site MS0053

Client: BC Iron Limited
Date: 16 August 2017
Location: Mardie Salt Project

Datum: UTM, GDA 94, Zone 50 K
Coordinates: **Easting:** 385373 mE **Northing:** 7653597 mN
Land System: Littoral land system

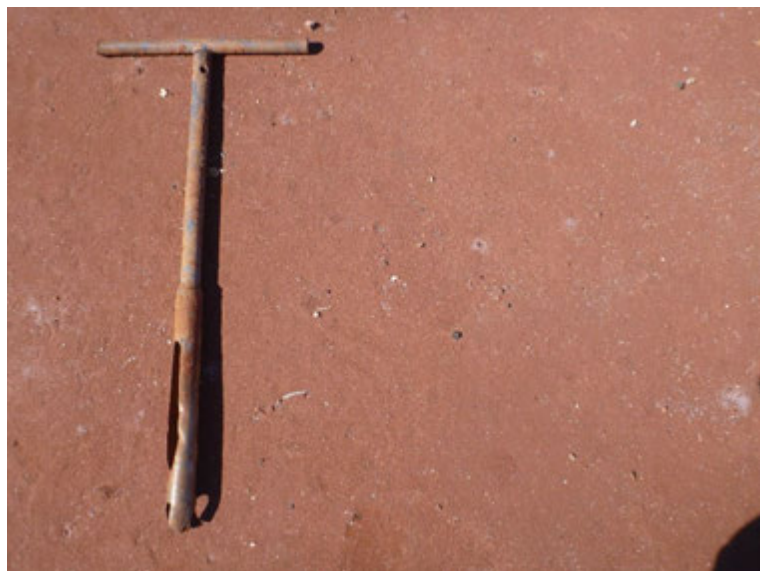
Plate B-12: Soil surface at Site MS0057

Client: BC Iron Limited
Date: 16 August 2017
Location: Mardie Salt Project

Datum: UTM, GDA 94, Zone 50 K
Coordinates: **Easting:** 386421 mE **Northing:** 7651773 mN
Land System: Littoral land system

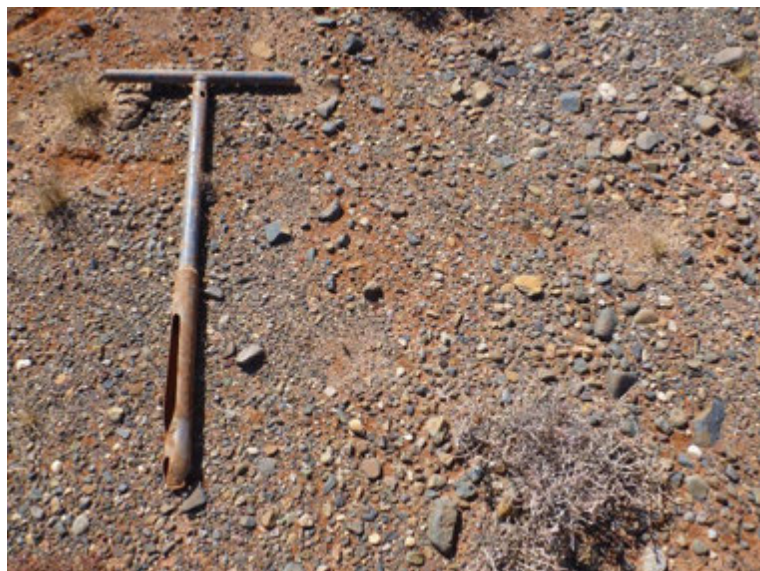
Plate B-13: Soil surface at Site MS0068

Client: BC Iron Limited
Date: 15 August 2017
Location: Mardie Salt Project

Datum: UTM, GDA 94, Zone 50 K
Coordinates: **Easting:** 389175 mE **Northing:** 7663016 mN
Land System: Littoral land system

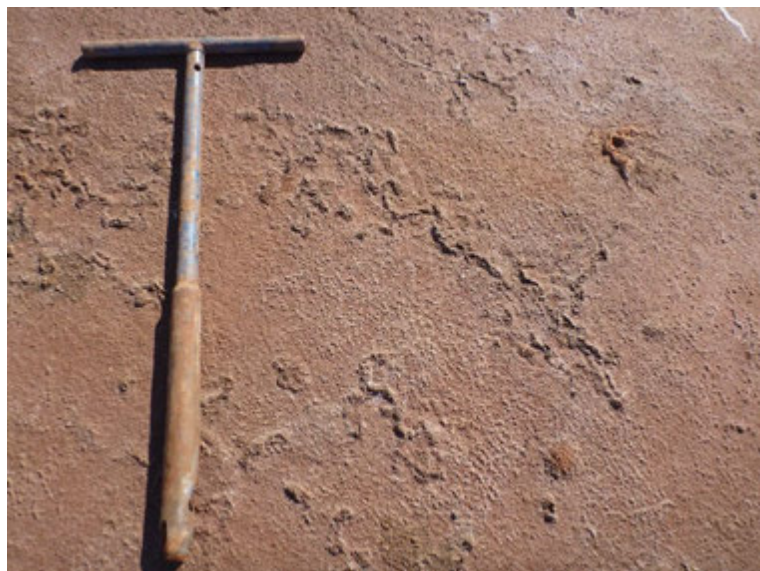
Plate B-14: Soil surface at Site MS0069

Depth	Material	Sample ID	Description
0 mbgl:	Topsoil	MS0069	Red-brown silty clay with very few shell fragments and minor salt precipitation on surface. Damp. No signs of mottling. No organic matter present. Water table at approximately 0.75 mbgl. Unable to sample soil at 1.0 mbgl due to high moisture content and mud-like consistency of the soil. As a result, the sample was not able to be collected by the auger.
0.25 mbgl:	Topsoil		
0.5 mbgl:	Subsoil		
0.75 mbgl:	Subsoil		
1.0 mbgl:	Subsoil (not sampled)

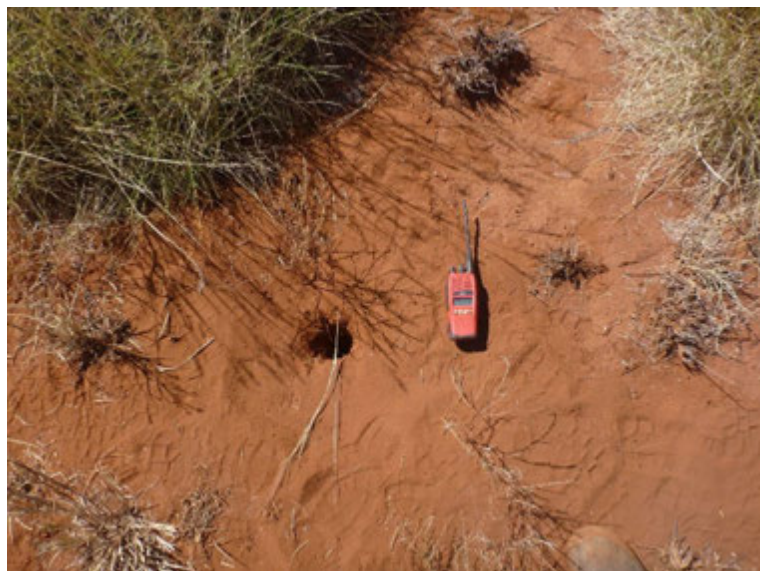
Plate B-15: Soil surface at Site MS0070

Depth	Material	Sample ID	Description
0 mbgl:	Topsoil	MS0070	Red-brown silty sand with no mottling. Medium to fine grained soil particles. Few organic matter and roots present throughout profile. Very dry. Unable to sample soil deeper than 0.25 mbgl due to the loose coherency of the soil profile.
0.25 mbgl:	Topsoil		
0.5 mbgl:	Subsoil (not sampled)		
0.75 mbgl:	Subsoil (not sampled)		
1.0 mbgl:	Subsoil (not sampled)

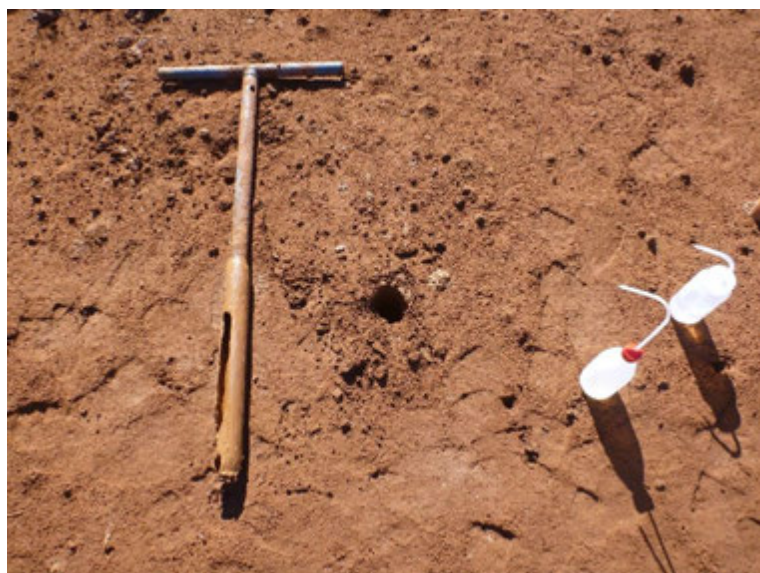
Plate B-16: Soil surface at Site MS0077

Depth	Material	Sample ID	Description
0 mbgl:	Topsoil	MS0077	Red-brown silty clay with very few broken shell fragments. Damp. No signs of mottling. No organic matter present. Water table at approximately 0.5 mbgl. Unable to sample soil below 0.5 mbgl due to high moisture content and mud-like consistency of the soil. As a result, the sample was not able to be collected by the auger.
0.25 mbgl:	Topsoil		
0.5 mbgl:	Subsoil		
0.75 mbgl:	Subsoil (not sampled)		
1.0 mbgl:	Subsoil (not sampled)

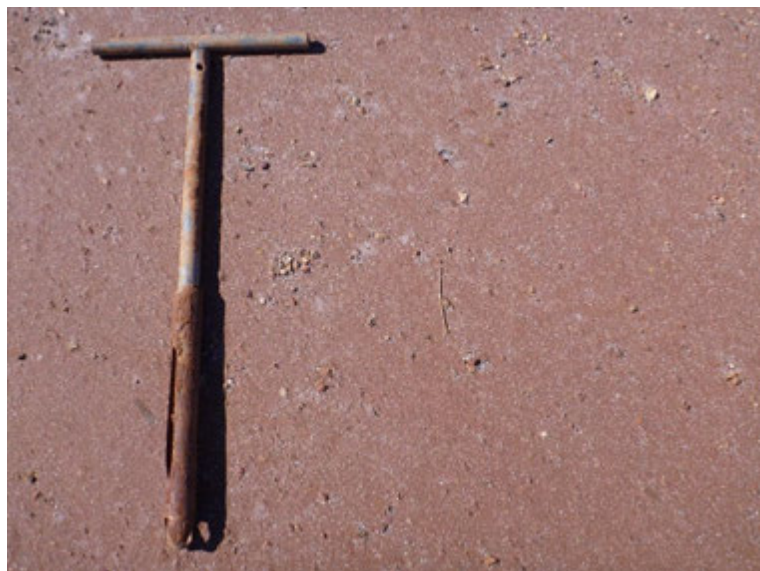
Plate B-17: Soil surface at Site MS0078

Client: BC Iron Limited
Date: 16 August 2017
Location: Mardie Salt Project

Datum: UTM, GDA 94, Zone 50 K
Coordinates: **Easting:** 385593 mE **Northing:** 7649607 mN
Land System: Littoral land system

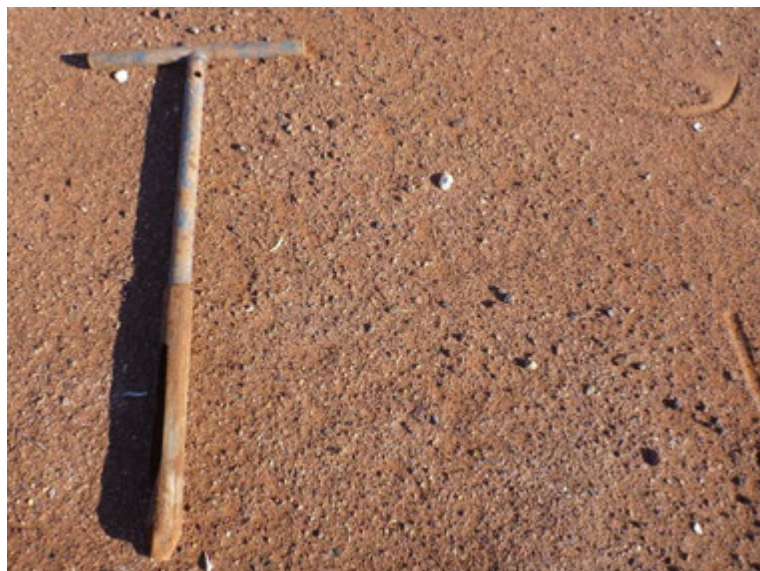
Plate B-18: Soil surface at Site MS0081

Client: BC Iron Limited
Date: 15 August 2017
Location: Mardie Salt Project

Datum: UTM, GDA 94, Zone 50 K
Coordinates: **Easting:** 388912 mE **Northing:** 9656661 mN
Land System: Littoral land system
